PROPERTY

Property Located At: Railway Ave Kayville, SK

Inspection Date: 19/08/2020

Report #: 190820

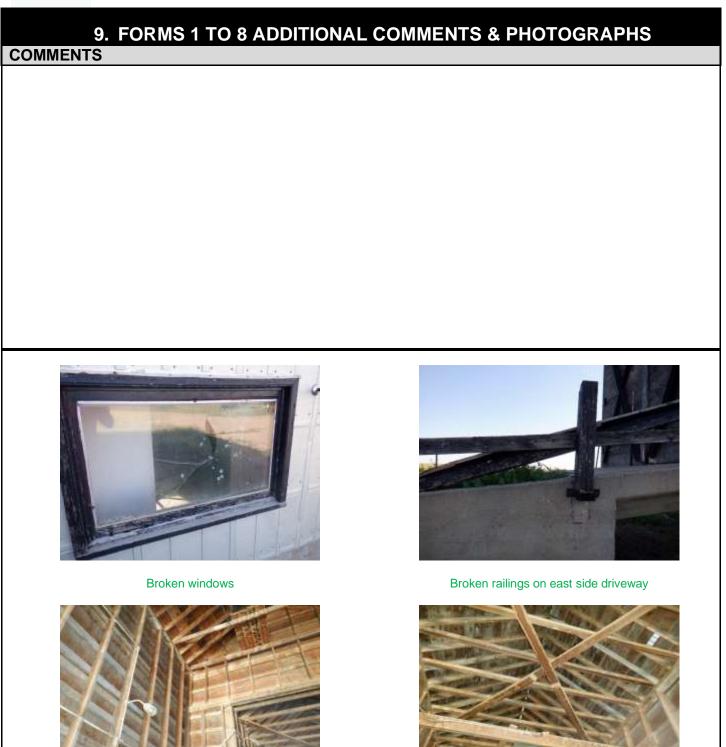
Main level wall/roof structure
