Geotechnical Report  
Proposed Sun Dale Subdivision  
Portions of Sections 28 and 29-21-22-W2M  
Sunset Cove, Saskatchewan

Val Lane Ltd.

File R3985.1

18 January 2008

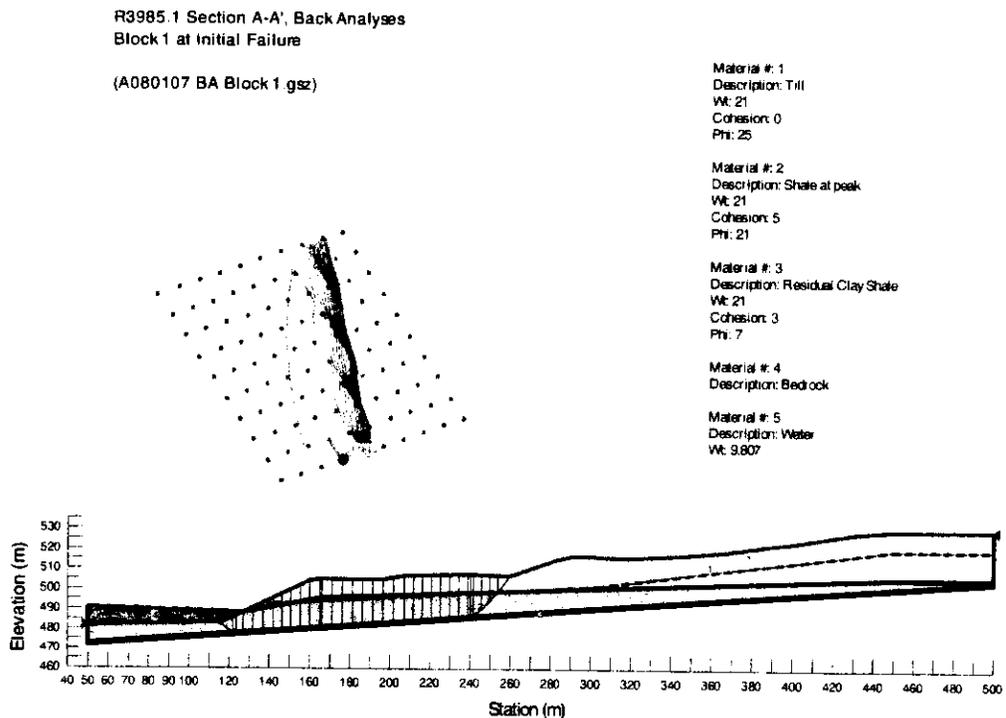
**Figure 7.2: Back Analysis of Block 1 for Cross Section A-A'**

The results of back analyses for Cross Section A-A' are illustrated on Figures 7.2 and 7.3. Results of back analyses are tabulated in Table 7.2. Figure 7.2 shows the analysis of Block 1, which is the landslide block closest to the lake. Figure 7.3 illustrates the analysis of Block 2, which includes Block 1 and a failure plan extending farther from the lake.

Both of these analyses and analyses for Cross Section B-B' required definition of a common failure plane that slopes down towards the lake. In addition, the soil profile at the toe of the slope was reduced by several metres to simulate the case where the lake bottom was lower in the vicinity of the toe prior to infilling. Without these assumptions, the soil strength parameters necessary to calculate a factor of safety close to 1.0 were unreasonably low.

Case	Calculated Factor of Safety
Cross Section A-A'	
• Block 1	0.99
• Blocks 1 and 2	1.02
Cross Section B-B'	
• Block 1	1.06
• Blocks 1 and 2	0.99
