Cypress PP - Site Inspection Report

RE: Other Inspection - Permit # No permit, called for assessment
23 Ben Vannoch,
Inspection Completed on 10/4/2023

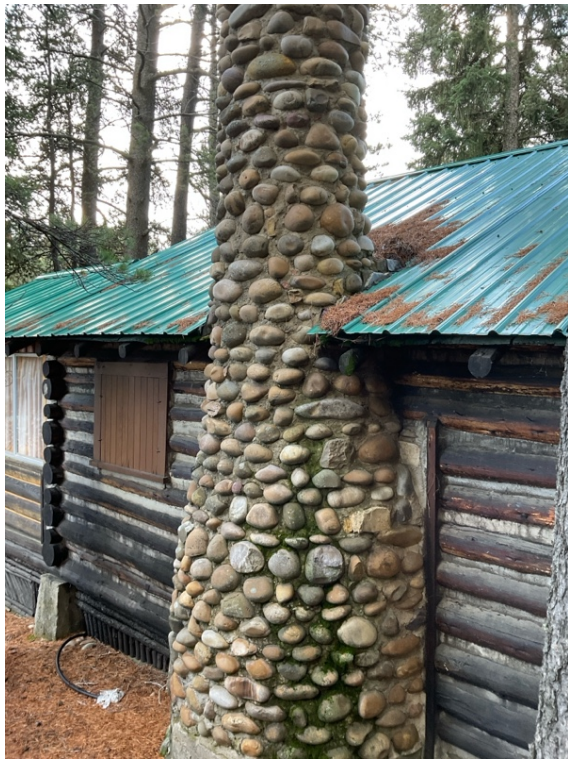
Fire place chimney still solid

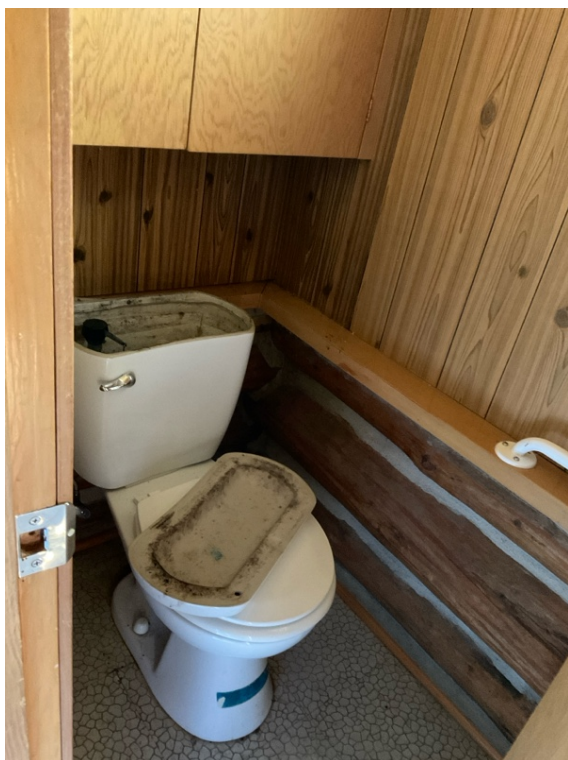
Toilet stall system drained

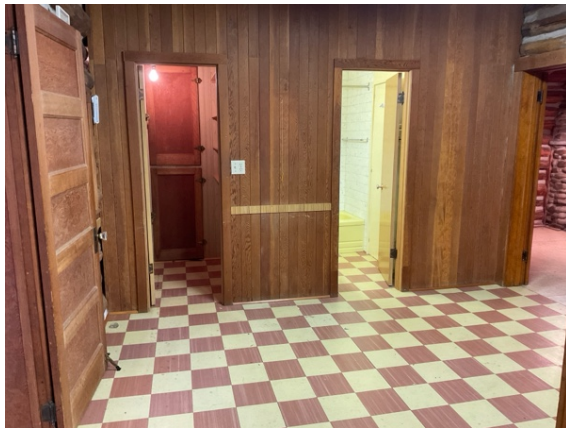
Pantry and bathroom no toilet
