November 1, 2023

ASBESTOS CONTAINING
MATERIALS INVENTORY

960 Logan Avenue, Winnipeg, Manitoba

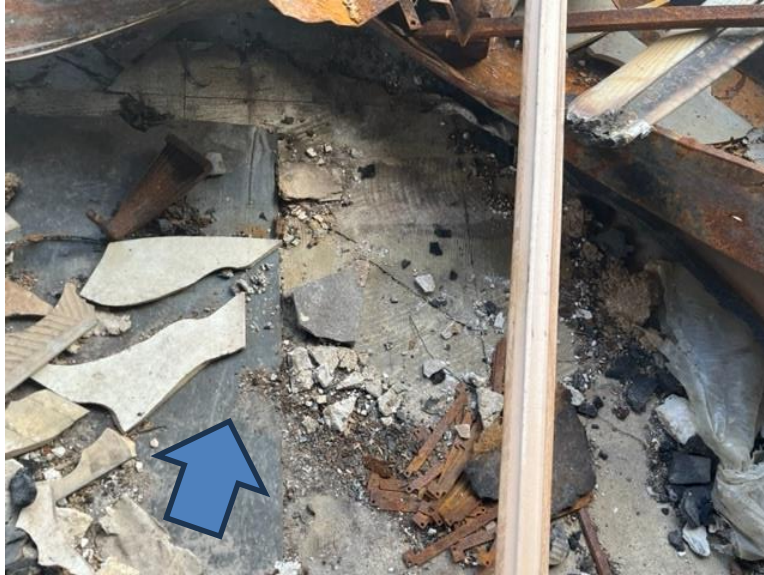
Blue vinyl sheet flooring was observed within the main floor of the east side of the building. The sample collected of this material (Sample S-009) was found to contain 1-5% Chrysotile asbestos. This material is non-friable and may also be located in other areas of the Site, potentially under other flooring materials.

Photograph 1: Showing an example of the asbestos blue vinyl sheet flooring located at the Site.

The blue vinyl sheet flooring located on the main floor east side of the building warehouse was found to contain asbestos. This material is non-friable, however can become friable during removal. Removal of this material can be handled safely under **Type 2** precautions. Please note that this material may also be located in other areas of the Site, potentially under other flooring materials.

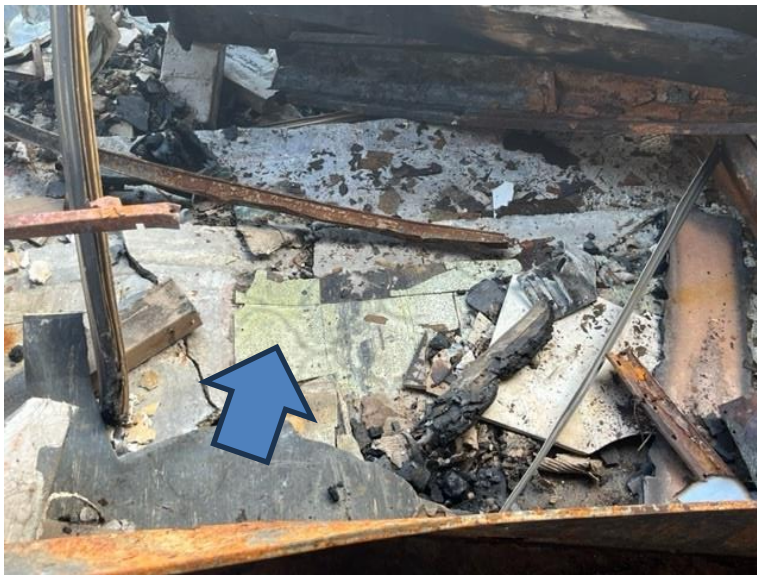
Vinyl floor tiles were observed within the main floor of the east side of the building. The samples collected of the red, blue and white vinyl tiles (Samples S-005, S-006 and S-008) were found to contain 10-25% and 1-5% Chrysotile asbestos. These materials are non-friable and may also be located in other areas of the Site, potentially under other flooring materials.

Photograph 2: Showing an example of the asbestos white vinyl floor tiles located at the Site.

The red, blue and white vinyl floor tiles located on the main floor east side of the building warehouse were found to contain asbestos. This material is non-friable and in good condition and can be safely managed in place until renovation or demolition may disturb this item. Removal of this material can be handled safely under **Type 1** precautions. Please note that this material may also be located in other areas of the Site, potentially under other flooring materials.

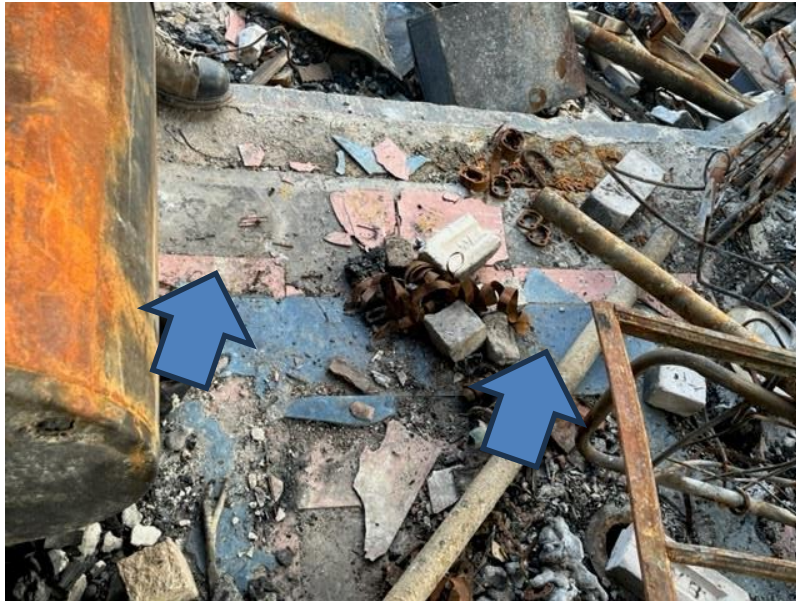
Photograph 3: Showing an example of the asbestos blue and red vinyl floor tiles located at the Site.

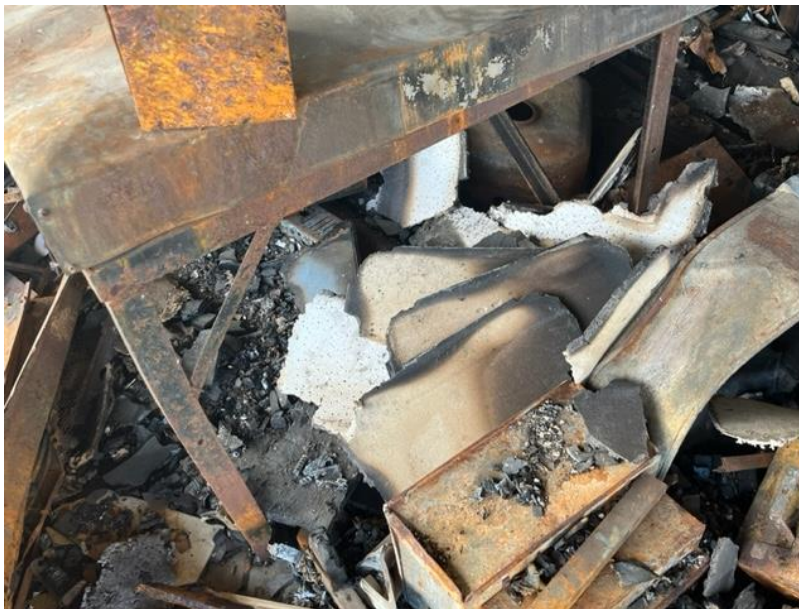
Ceiling tiles were observed on the main floor of the building. The sample collected of the ceiling tile (Sample S-007) were found to be non-asbestos.

Photograph 4: Showing an example of the non-asbestos ceiling tiles located at the Site.

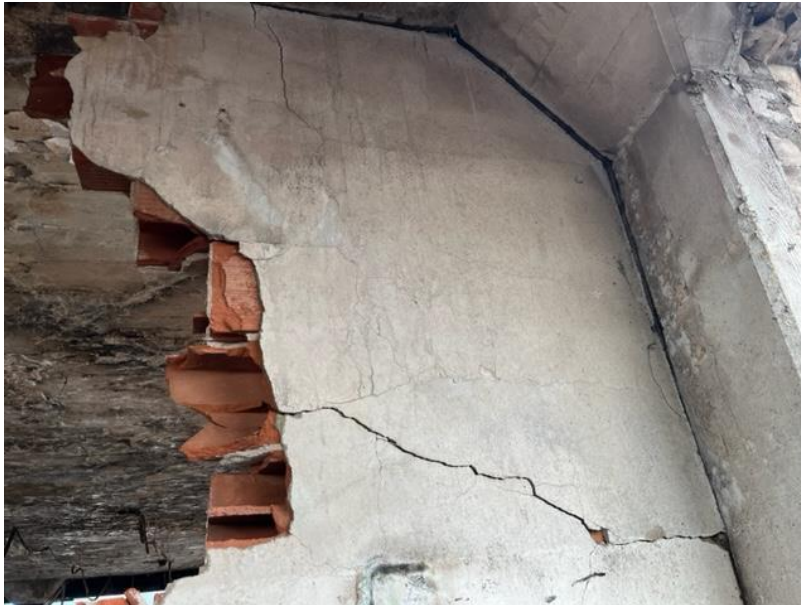
Plaster was observed to have been installed on walls and ceilings throughout the Site. Plaster samples collected (Samples S-003A, S-003B, S-003C, S-003D, S-003E, S-003F, S-003G, S-003H, S-004A, S-004B, S-004C, S-004D, S-004E, S-004F, S-004G and S-004H) were found to be non-asbestos.

Photograph 5: Showing an example of the non-asbestos plaster located on the main floor of the Site.

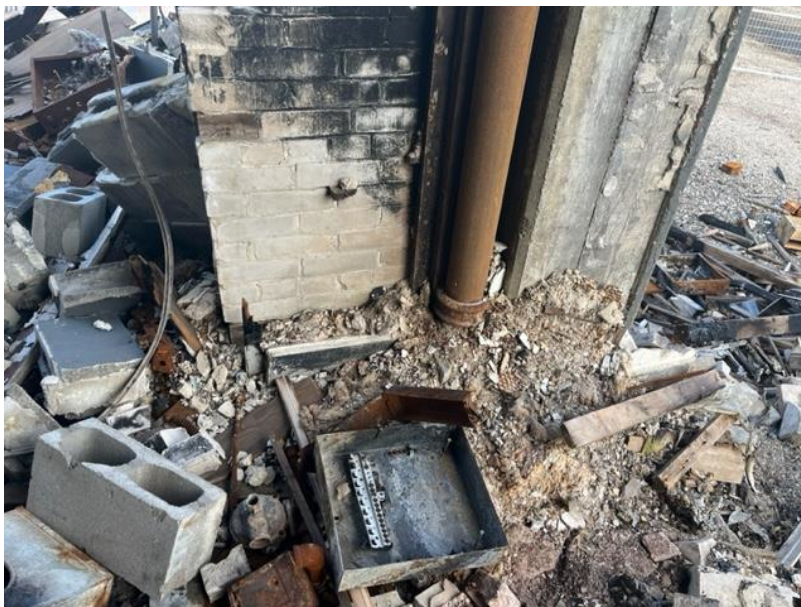
Brick mortar were observed on the exterior of the warehouse building. The samples collected of this material (Samples S-001A, S-001B, S-001C and S-002) were found to be non-asbestos.

Photograph 6: Showing an example of the non-asbestos brick mortar located at the Site.

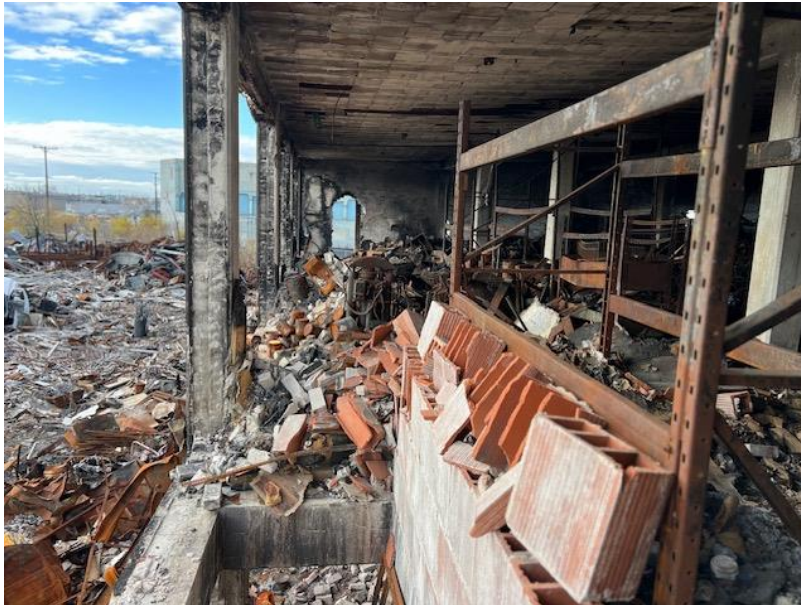
Photograph 6: Showing an example of the non-asbestos brick mortar located at the Site.

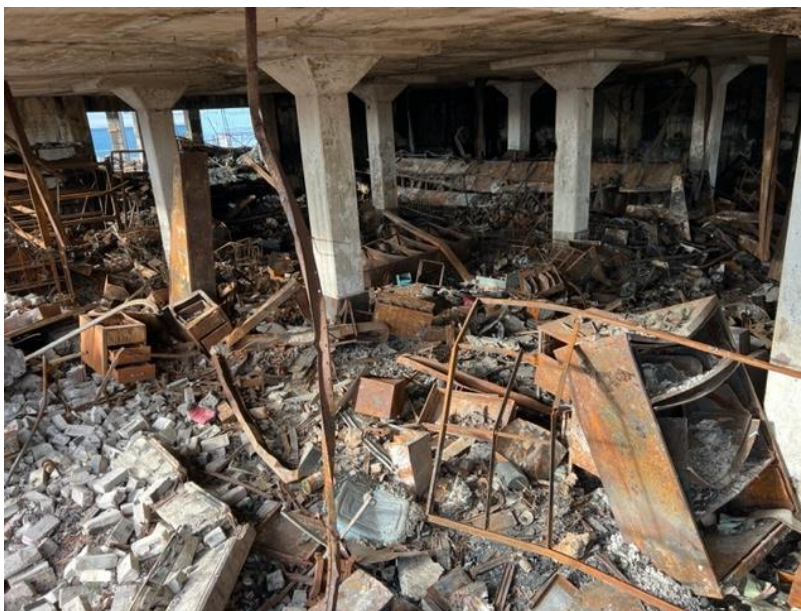
Photograph 7: Showing the extensive fire damages looking throughout the second floor of the building.

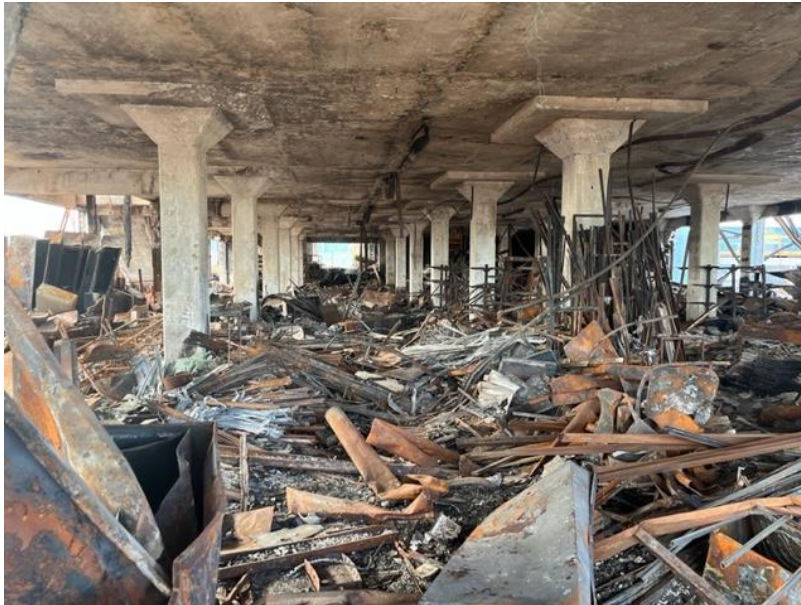
Photograph 8: Showing the extensive fire damages looking throughout the main floor of the building.

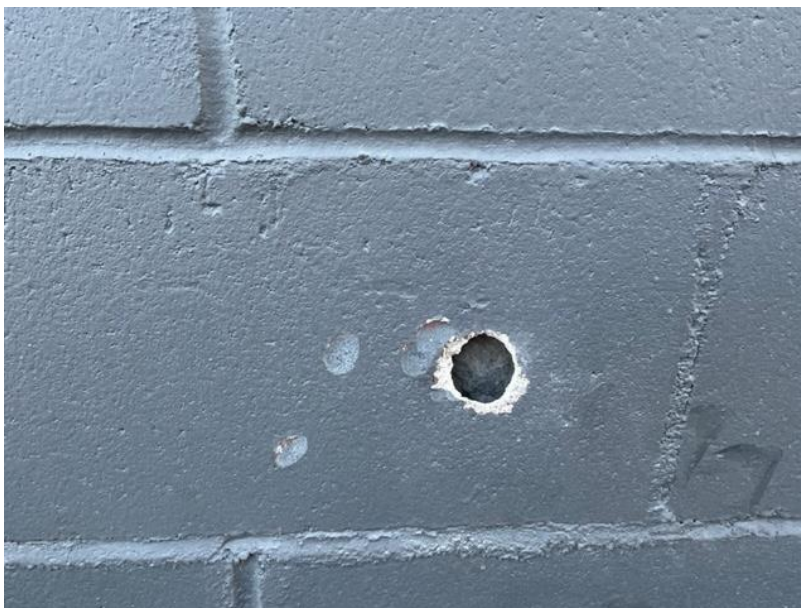
Photograph 9: Showing a hole in the cinder block exterior wall observing to have no vermiculite within the walls.

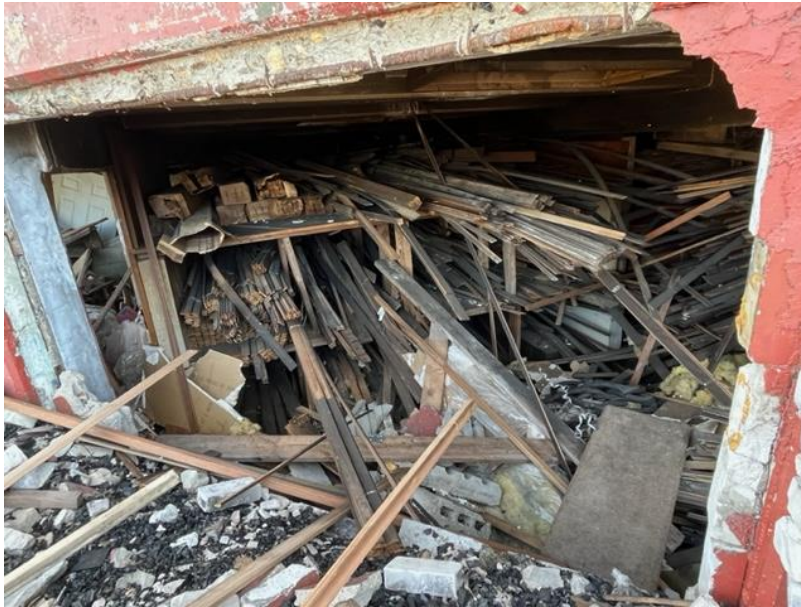
Photograph 10: Showing the extensive fire damages in the basement of the building which has no access at the time of assessment.

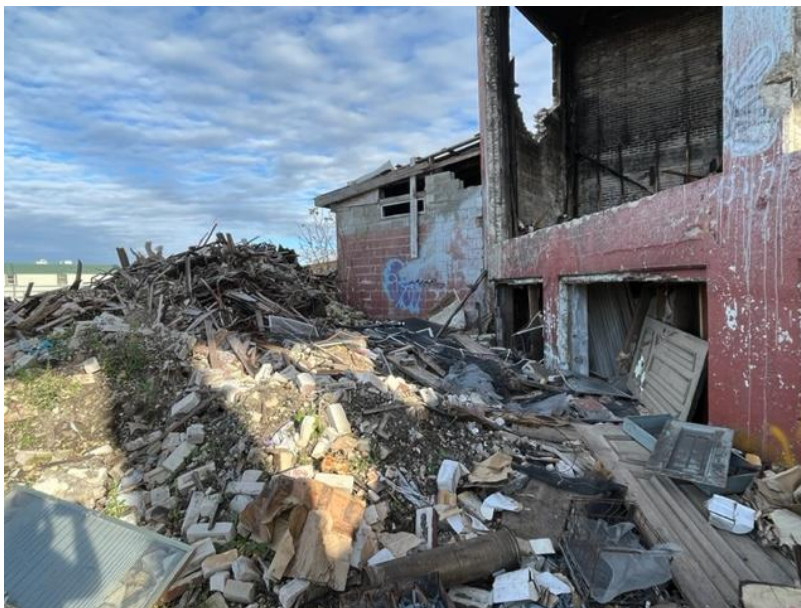
Photograph 11: Showing the extensive fire damages within the exterior of the building.
