## Edmonton Master Filter

Internal WO #	27899
Company Name	NRIP Logistics
Contact	Nachos
Service Level	Gold
Filter Type	DPF
Cleaning Date	27/05/2024
Technician	Alex

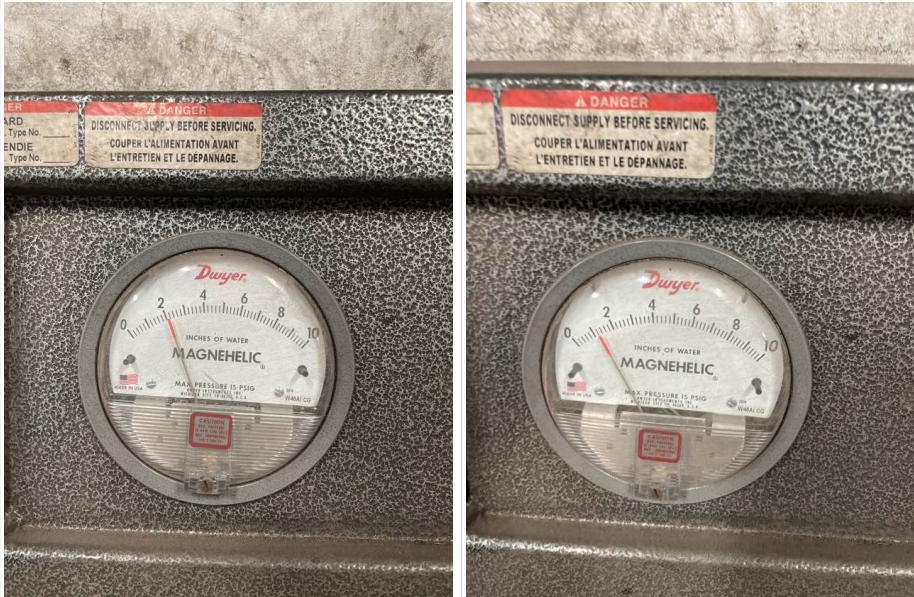
Note	Testing results are available for DPF and EGR cleans only. There are no satisfactory testing methods for DOCs, SCRs and OneBox systems, and we are unable to guarantee the status of the wash coats on these catalysts.
Pre & Post Flow Reading Images

Initial Flow Bench Test (in/hg)	2.10
Final Flow Bench Test (in/hg)	1.10
Flow Green Range (in/hg)	1.1-1.6
Clean Pin Gauge Depth	10"
