Geotechnical Report  
Proposed Sun Dale Subdivision  
Portions of Sections 28 and 29-21-22-W2M  
Sunset Cove, Saskatchewan

Val Lane Ltd.

File R3985.1

18 January 2008

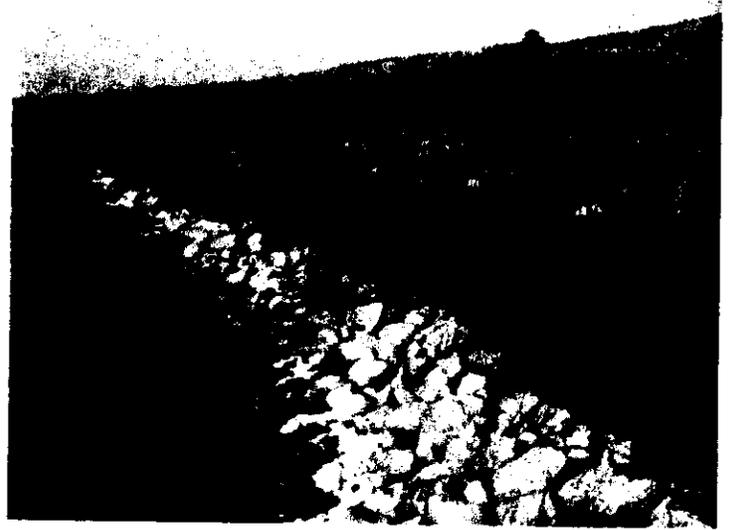
2. West from point, good rip rap armour  
071002 to 05 Field Trip 008.jpg

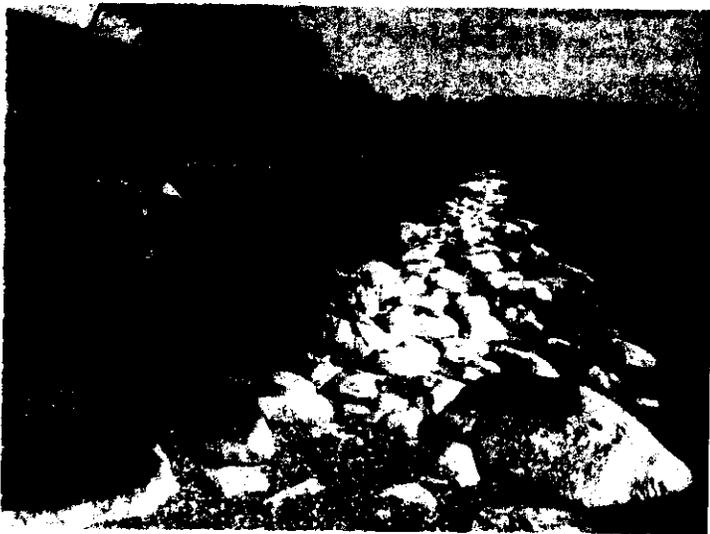
3. East from point, good rip rap on shore  
071002 to 05 Field Trip 009.jpg

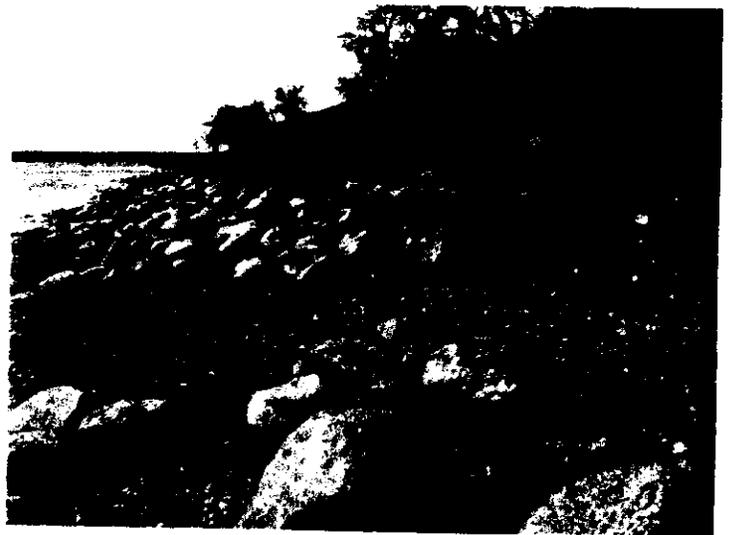
4. West near beach area, thinner rip rap, sand  
071002 to 05 Field Trip 010.jpg

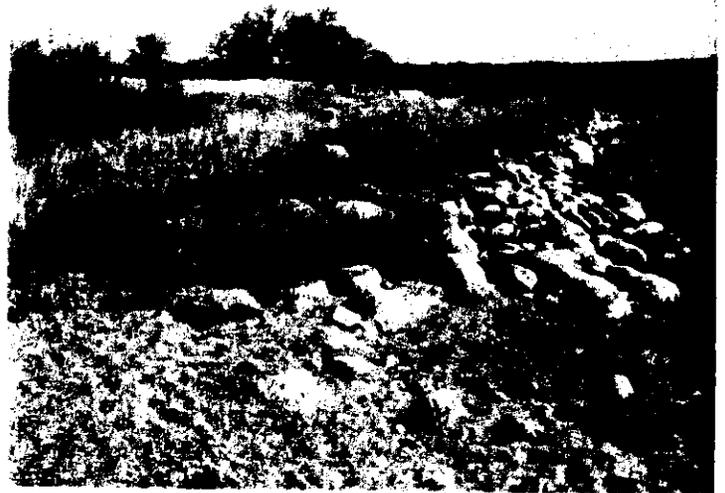
6. Sand transition to cobbles to east  
071002 to 05 Field Trip 012.jpg

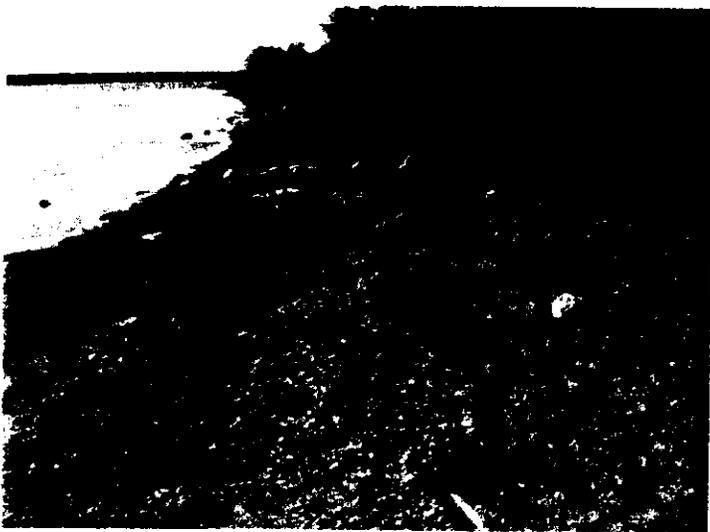
7. View west, sandy beach area  
071002 to 05 Field Trip 013.jpg

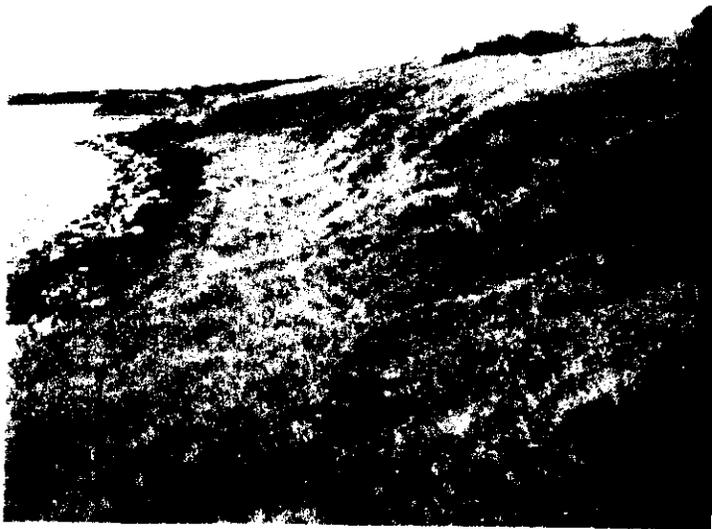
9. Shale exposure  
071002 to 05 Field Trip 015.jpg

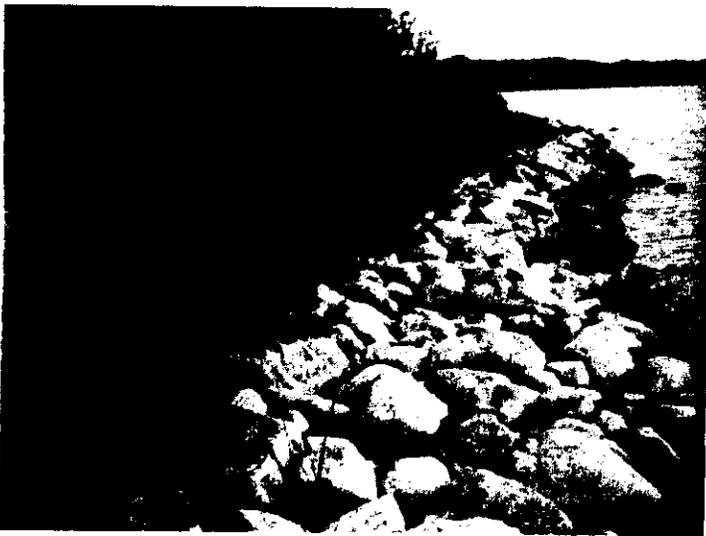
11. View east of west point, dense rip rap  
071002 to 05 Field Trip 017.jpg

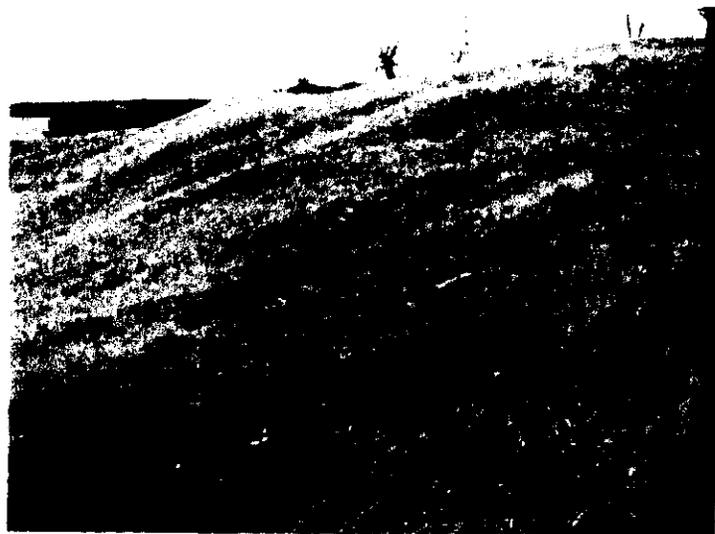
13. Exposed shale, east of BH102  
071002 to 05 Field Trip 019.jpg

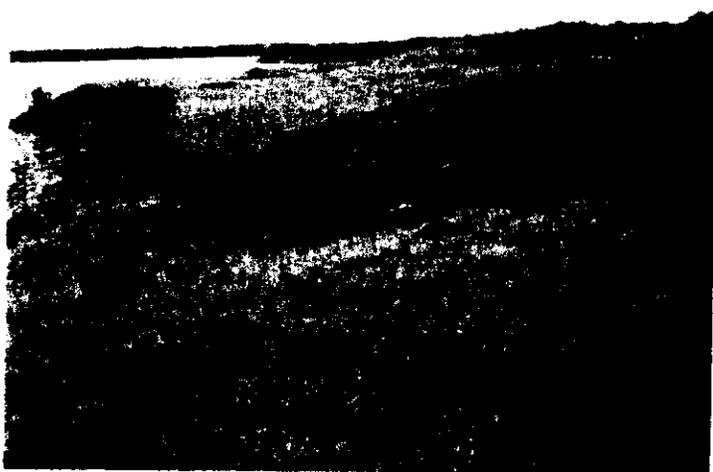
15. view west, east of BH104 across eroded shale  
071002 to 05 Field Trip 021.jpg

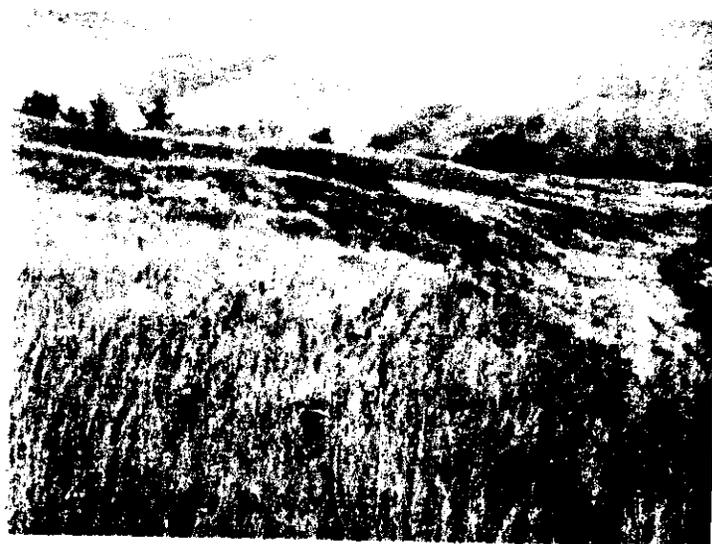
16. View east, shale slope and beach  
071002 to 05 Field Trip 022.jpg

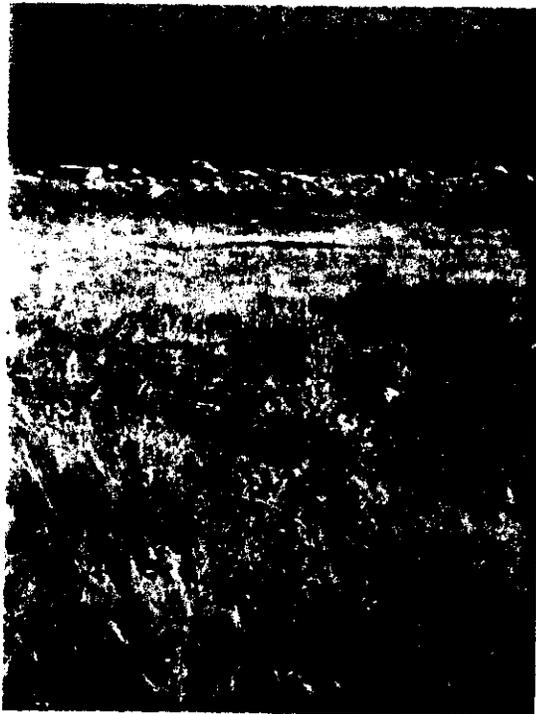
17. Eroded slope, wide beach has formed  
071002 to 05 Field Trip 023.jpg

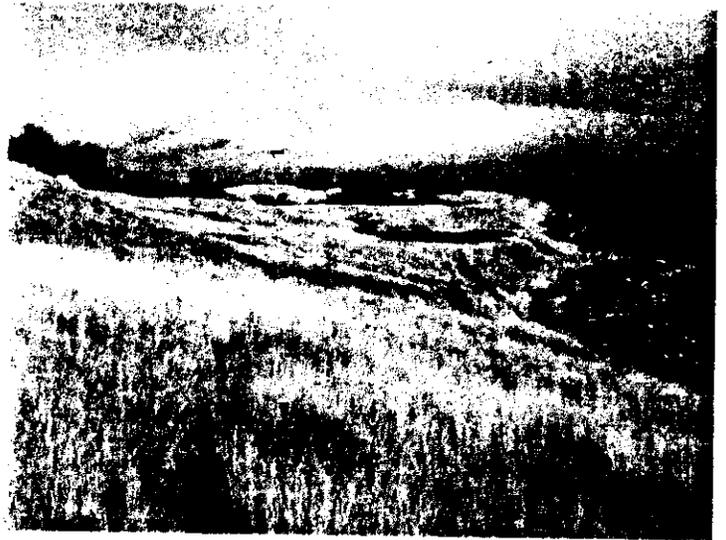
18. Shale slope mid picture eroded to form scalloped shore  
071002 to 05 Field Trip 024.jpg

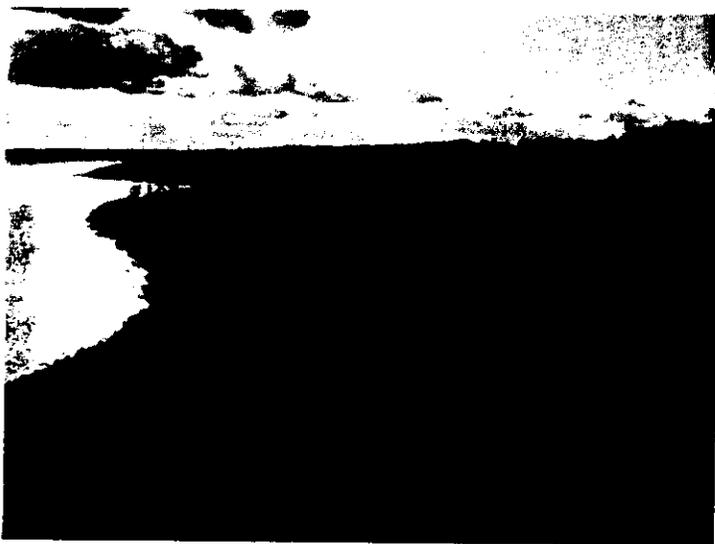
29. West along bluff, thin till at surface  
071002 to 05 Field Trip 035.jpg

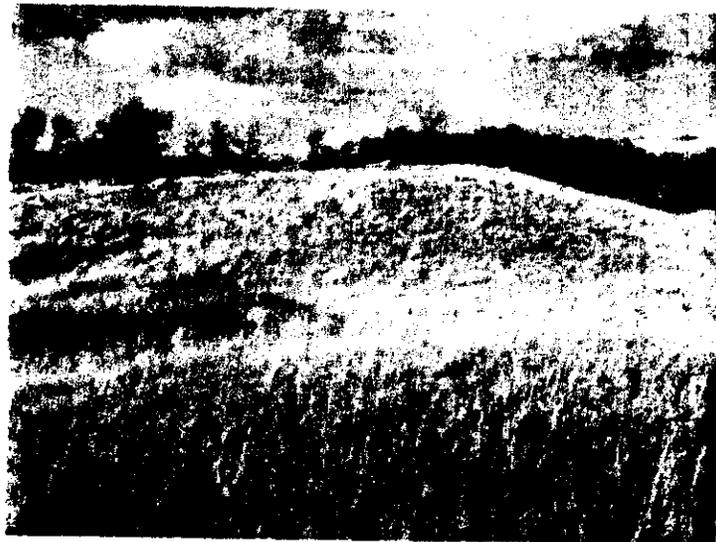
30. Bouldery knoll (BH101)  
071002 to 05 Field Trip 036.jpg
